Soil Mechanics Surface Sampler

R. F. SCOTT¹ AND F. I. ROBERSON²

A lunar surface sampler essentially identical to that operated from Surveyor 3 was mounted on Surveyor 7 and performed flawlessly on the moon throughout a range of operating temperatures from $+180^{\circ}\text{F}$ to -167°F . The motor current was sampled during lunar bearing and trenching tests, and these data, together with preflight calibrations enabled us to calculate the forces involved in these tests. After minimal lunar surface testing, the surface sampler was employed to release the sensor head of the α -scattering instrument, which had jammed in its background position. Subsequently, the sensor head was relocated to analyze a rock and, still later, to analyze some subsurface lunar material. The mechanical tests of the surface in the vicinity of Tycho indicated that the surface behaved in a manner that was quantitatively similar to the behavior of the material close to Surveyor 3, but the surface near Tycho appeared qualitatively to be more deformable and less brittle. A rock was weighed and found to have a density between 2.4 and 3.1 g/cm³ (earth basis). Another rock was broken by a moderately hard blow fro

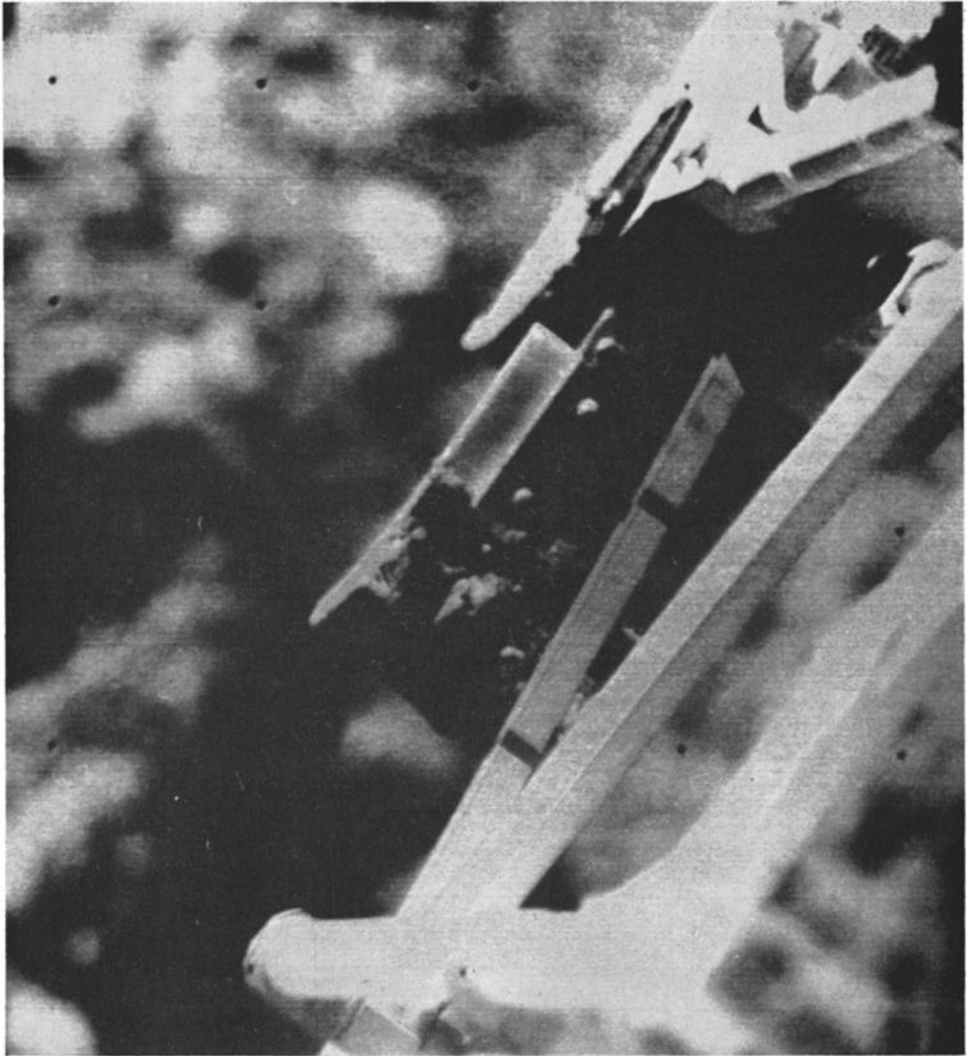
Fig. 20. Fragment adhering to surface-sampler magnets after lunar surface was contacted.

and the scoop door was opened. A rock fragment was observed, apparently adhering to the scoop door. To afford a closer television view, the scoop was elevated two 2.0-second steps, and a narrow-angle television picture was taken (Figure 20). Subsequent attempts to move the scoop into the stereo view area for closer television study of the fragment resulted in its loss before the stereo view was achieved.

Careful photographic studies were made of the two small horseshoe magnets, located in the base of the scoop door, both before lunar surface operations and at various times during the first lunar day. The magnets apparently picked up a coating of magnetic material from the lunar surface. In addition, the surface sampler was dragged through the surface at a selected location in order to determine if a small fragment of lunar surface had magnetic characteristics. A fragment was, in fact, found adhering to the surface sampler, which was elevated for better inspection of the fragment (see Figure 20).

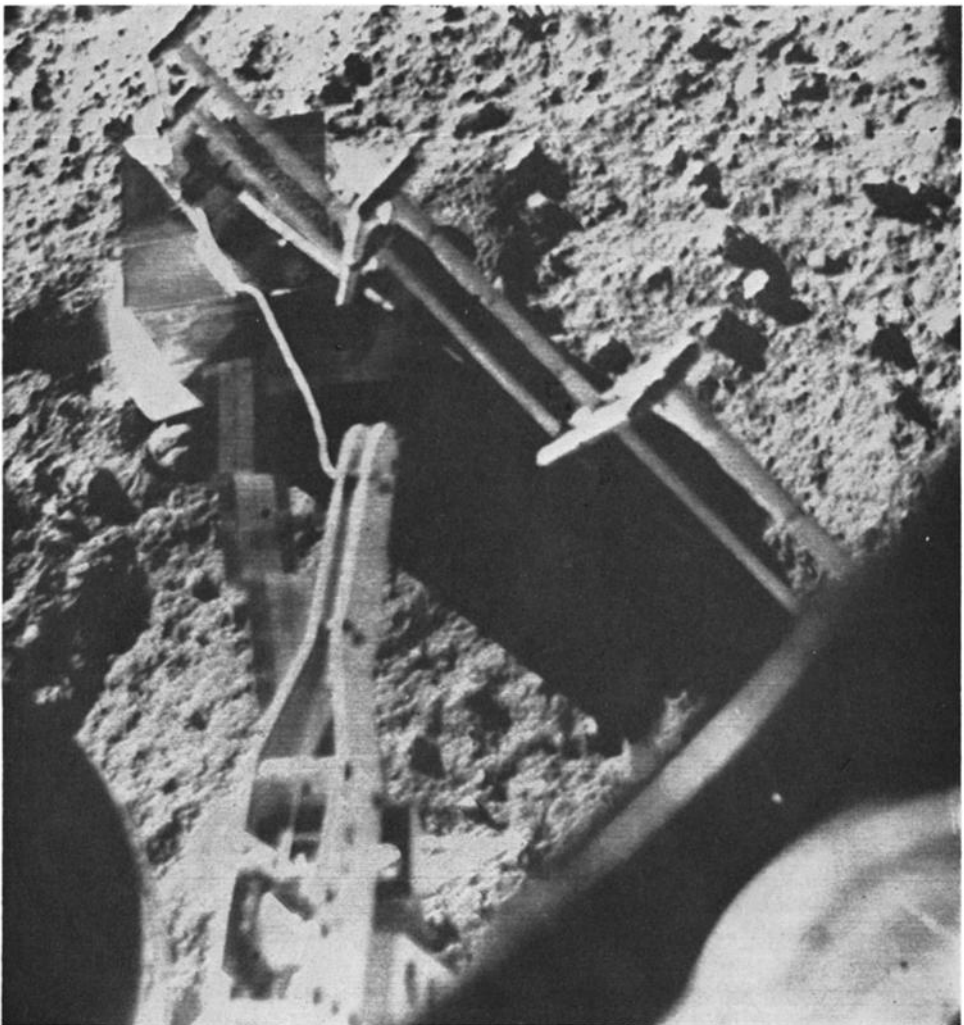
Fig. 21. Surface sampler nearing final position in deploying sensor head to second sample on the lunar surface.

The continuation of extend and left azimuth commands led to the position shown in Figure 21, in which the target rock sample is seen at the lower-left corner of the sensor head. Continued maneuvering led to the positioning of the sensor head viewing port over this rock, as noted in Figure 16. In Figure 22 the ring around the rock shows the final position achieved.

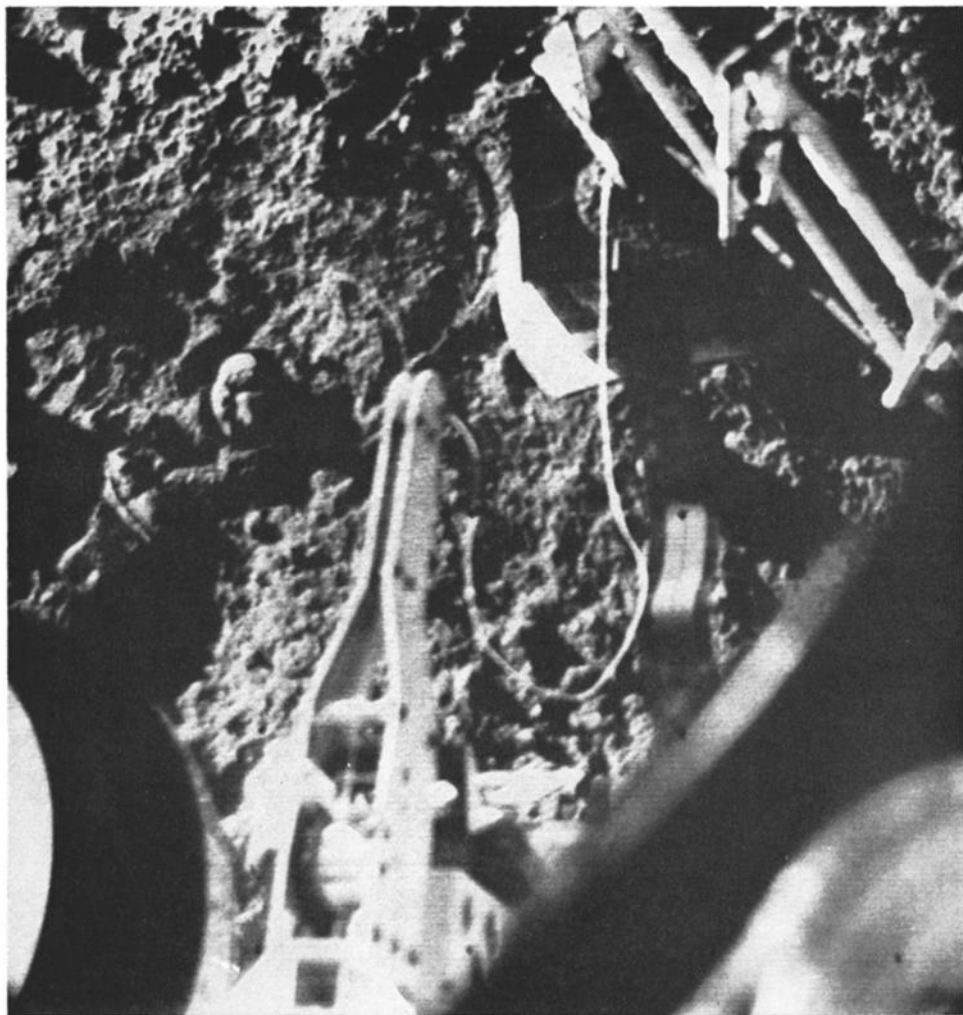
Fig. 22. Surface sampler in process of moving sensor head from second to third lunar sample. Note ring around target rock at second sample location.

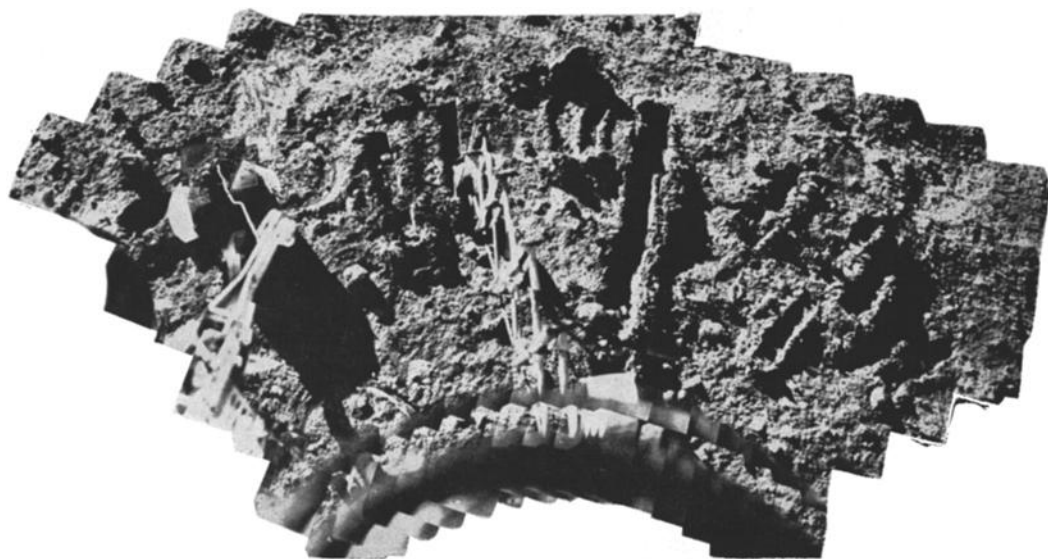
Fig. 23. Mosaic of area of operations.

Figure 23 shows the accomplishments of the surface sampler by day 021, toward the end of the first lunar day. In this mosaic, the α -scattering instrument can be seen in its second de-

ployed position at the left-hand side of the picture; the surface sampler is in the process of excavating subsurface soil to provide the third sample for analysis. Some of the surface-sampler tests, identified in Figures 10 and 16, may also be seen in Figure 23. In particular, just to the right of the position of the surface sampler, a fairly large rock (rock B) is seen at the outer edge of the surface-sampler area. On the near side of the rock, two small trenches demonstrate that the rock was just outside the surface sampler's reach. To the right of the rock is a long, 15- to 18-cm-deep trench, identified as trench 2 in Figure 10.

Some shorter trenches are visible on the right-hand side of Figure 23; on the extreme right-hand edge lies a shallow trench, which was the first trench attempted. This trench could be excavated to a depth of only 2.5 to 5 cm because of the presence of rock immediately below the surface. At the foot of this trench is a small rock fragment (rock E), which was broken by the surface sampler into two fragments after the picture was taken. On the left-hand side of the figure, just to the right of the shadow cast by the sensor head is a somewhat rounded rock (rock A), which was weighed. Many surface-sampler operations involved this rock, which

total depth of penetration of the surface sampler into the lunar soil in Figure 23 was about 5 cm in this test. The test was apparently located on the edge of a small surface depression, which became obvious in pictures taken later in the lunar day. Consequently, the surface subjected to the test (Figure 24) slopes downward to the right, which accounts for the unsymmetrical appearance of the deformed soil. At this location, the surface sampler was at an extension distance of about 103 cm from the spacecraft (see Figure 23), and consequently applied its force at an angle to the surface rather than directly downward. In the disturbed lunar sur-

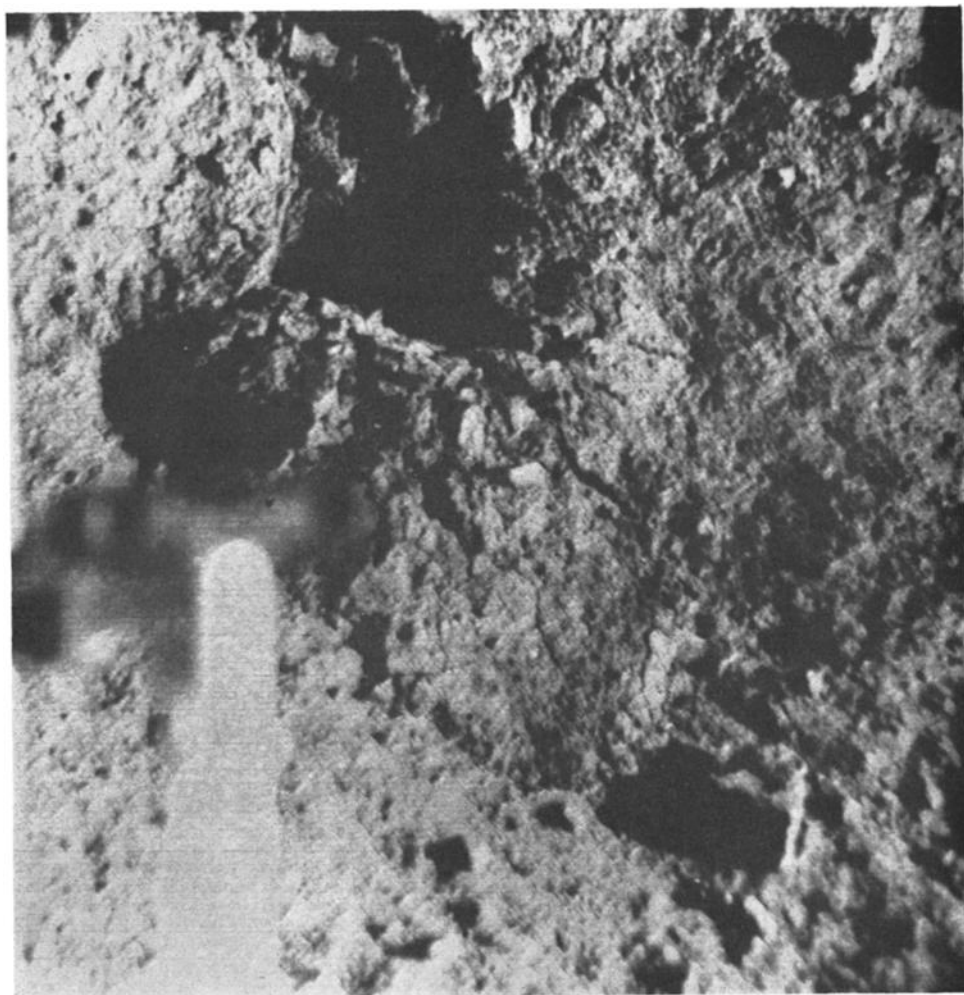
Fig. 24. Results of bearing test 1.

Figure 24 shows a view of the result of bearing test 1, which was performed by means of two 2.0-second down commands in which the motor current was recorded. The disturbed soil shows a remarkable resemblance to the appearance of the lunar surface at the Surveyor 3 site following the first bearing test performed at that location [Scott and Roberson, 1967]. The

face material, a certain amount of minor cracking appears, together with an obvious general bulging of the area.

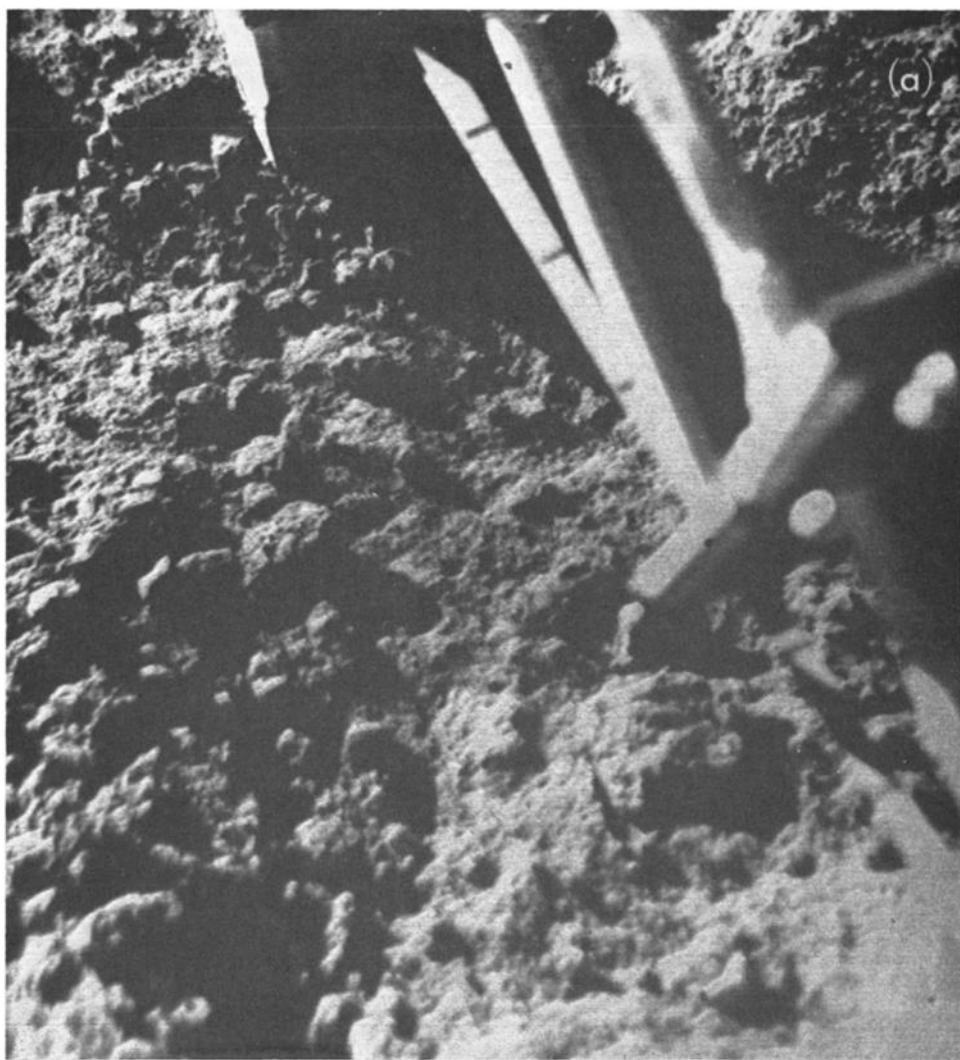
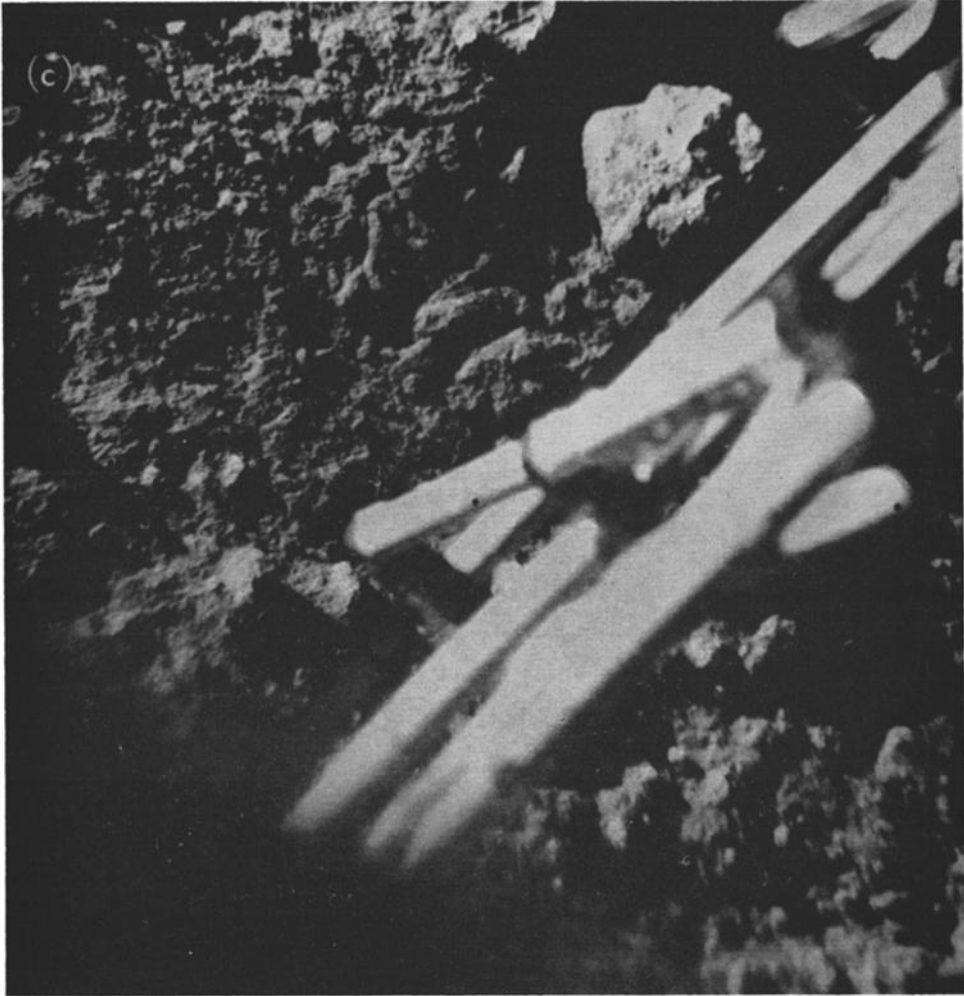
Fig. 25*a*. Bearing test 13.

Fig. 25a. Bearing test 13.

azimuth commands positioned the surface sampler for bearing point 13. This bearing test and trenching operation were executed in the same manner as bearing test 12 and trench 5. Command tape 907 was used to execute five 0.5-second lower commands, followed by four 2.0-second retract commands. The surface sampler remained in contact with the surface at the foot of trench 6 at the end of operations on day 021.

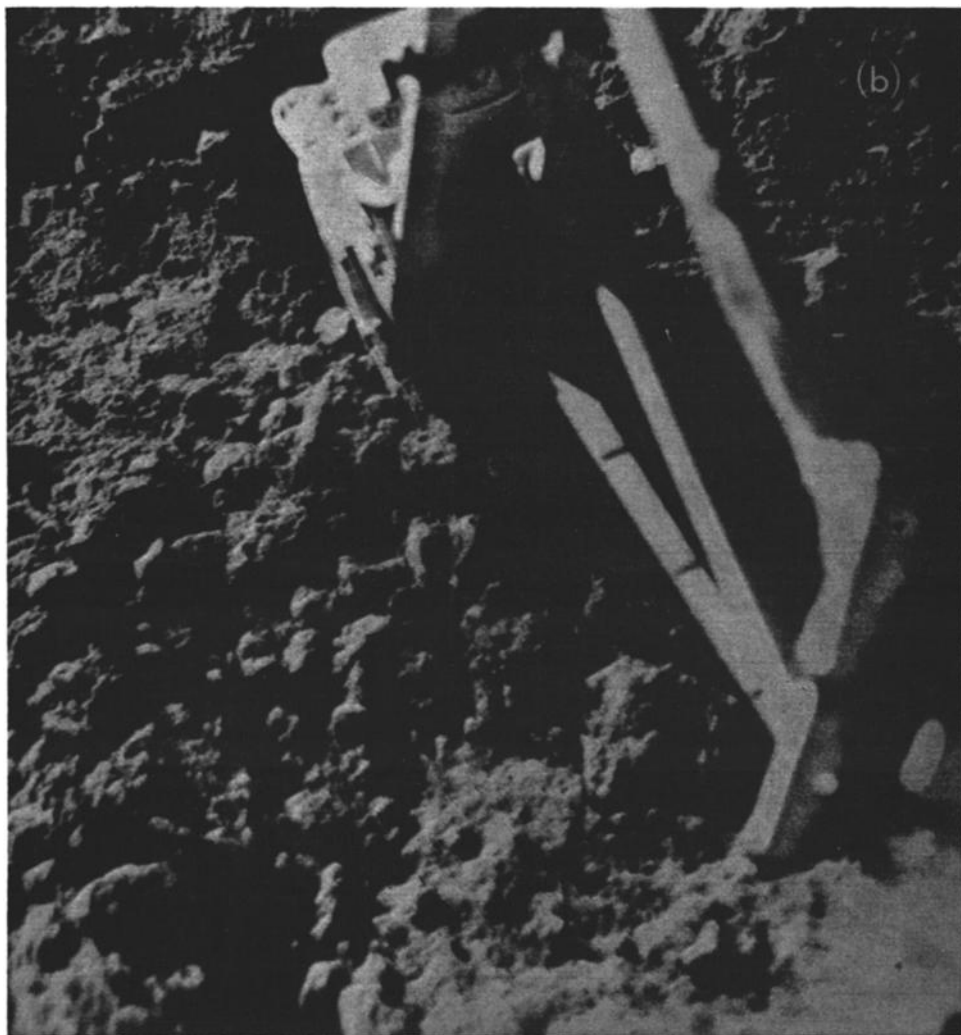
Fig. 25*b*. Trench 6, performed in sequence at the sample point.

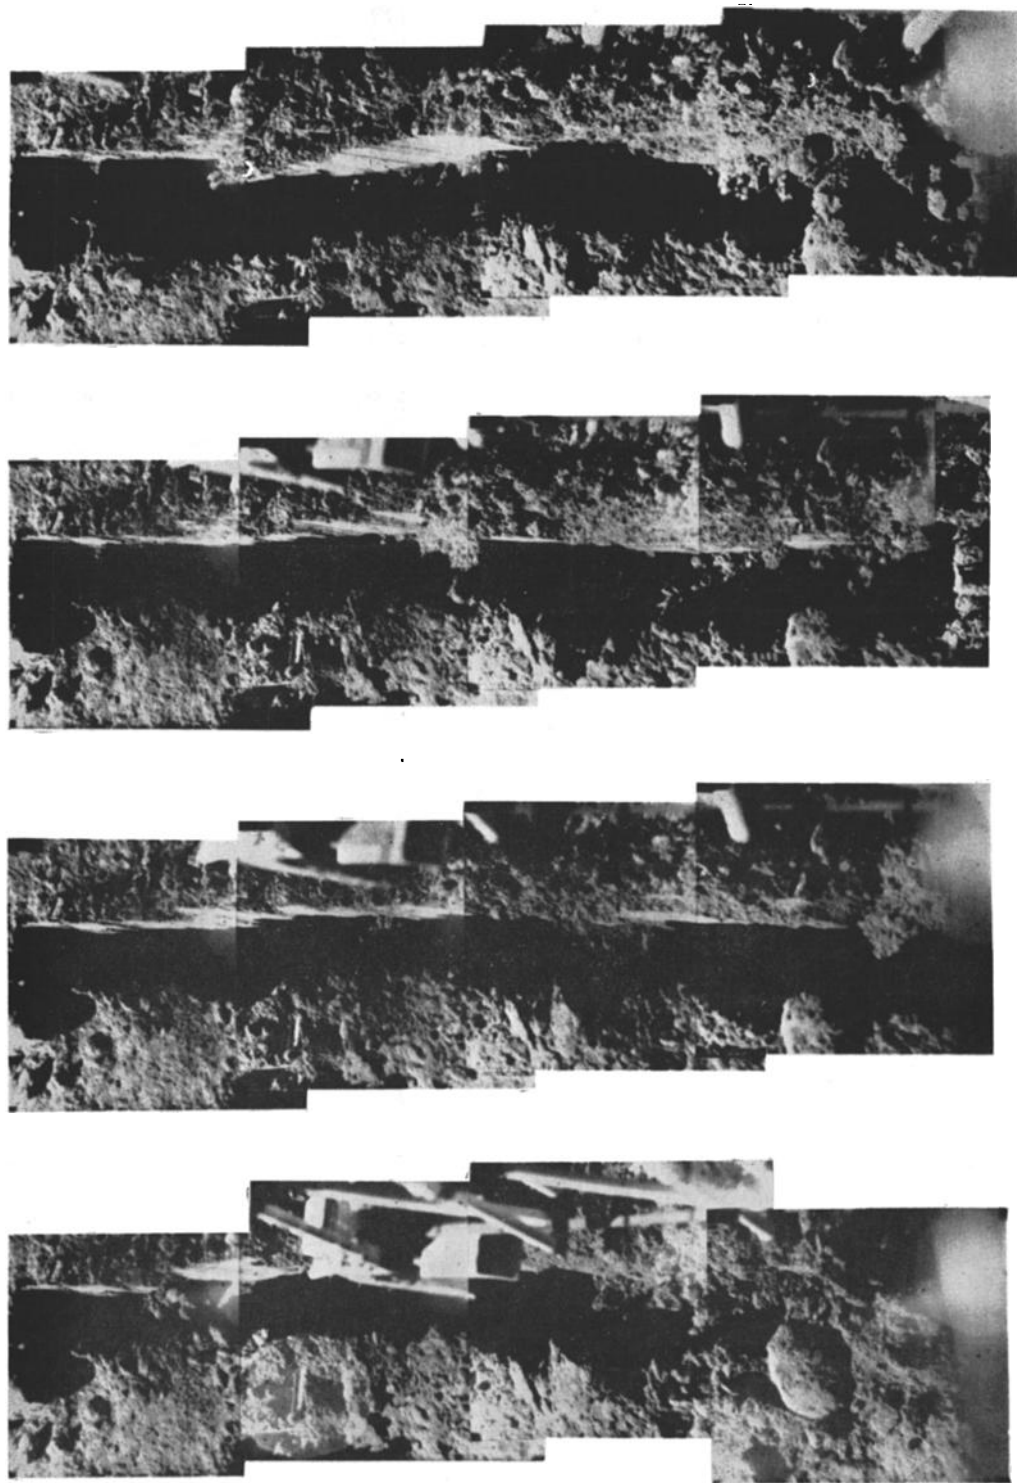
Fig. 26. Four mosaics of trench 2, each taken after a successive pass through the trench, showing trenching progress, left to right.

Several trenching passes were made through this trench, which was eventually enlarged to a length of approximately 75 cm, a depth of about 15 cm, and a width of 5 cm. Two obstructions were observed in this trench, one at the head of the trench, where the surface sampler was deflected to the left around some subsurface object, and one approximately two-thirds of the way down the trench toward the spacecraft, where a small protuberance again interrupted surface-sampler operations. The retraction motor stalled on the object, which could not be extracted from the surface, and was thereupon avoided in trenching operations. The appear-

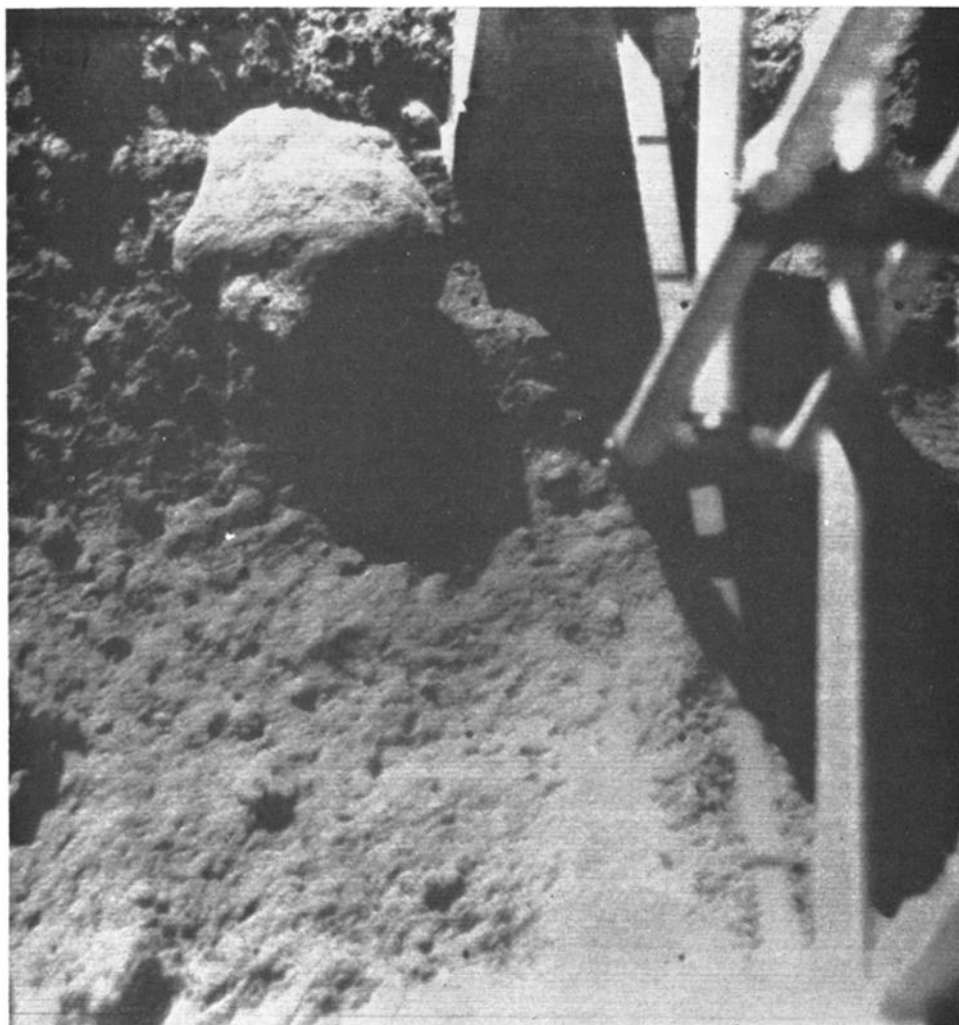
Fig. 27a. Direct view of rock A after it was moved.

of the rock has only been estimated from its over-all dimensions; its density will be discussed in a following section. The pictures of rock A used in the measurements are shown in Figures 27a and 27b.

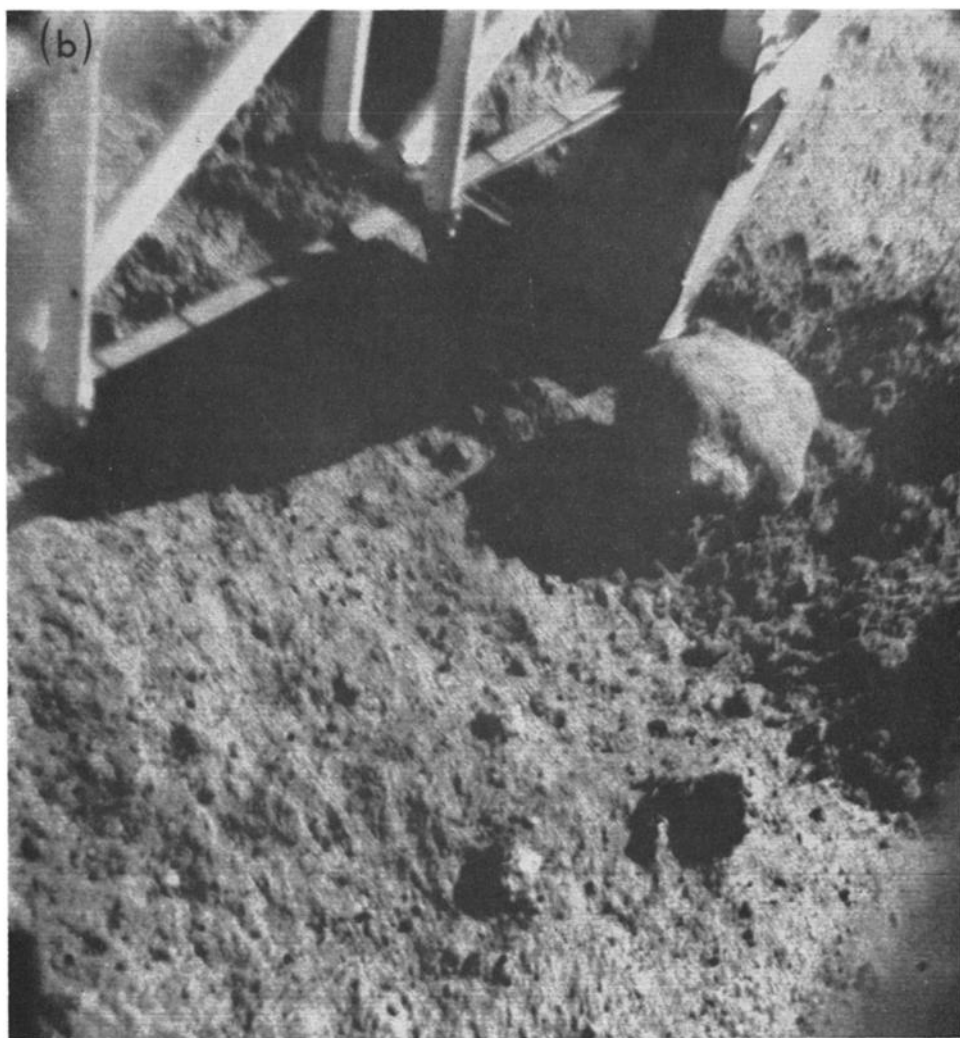
Fig. 27b. View through the stereo mirror. Rock A after it was moved.

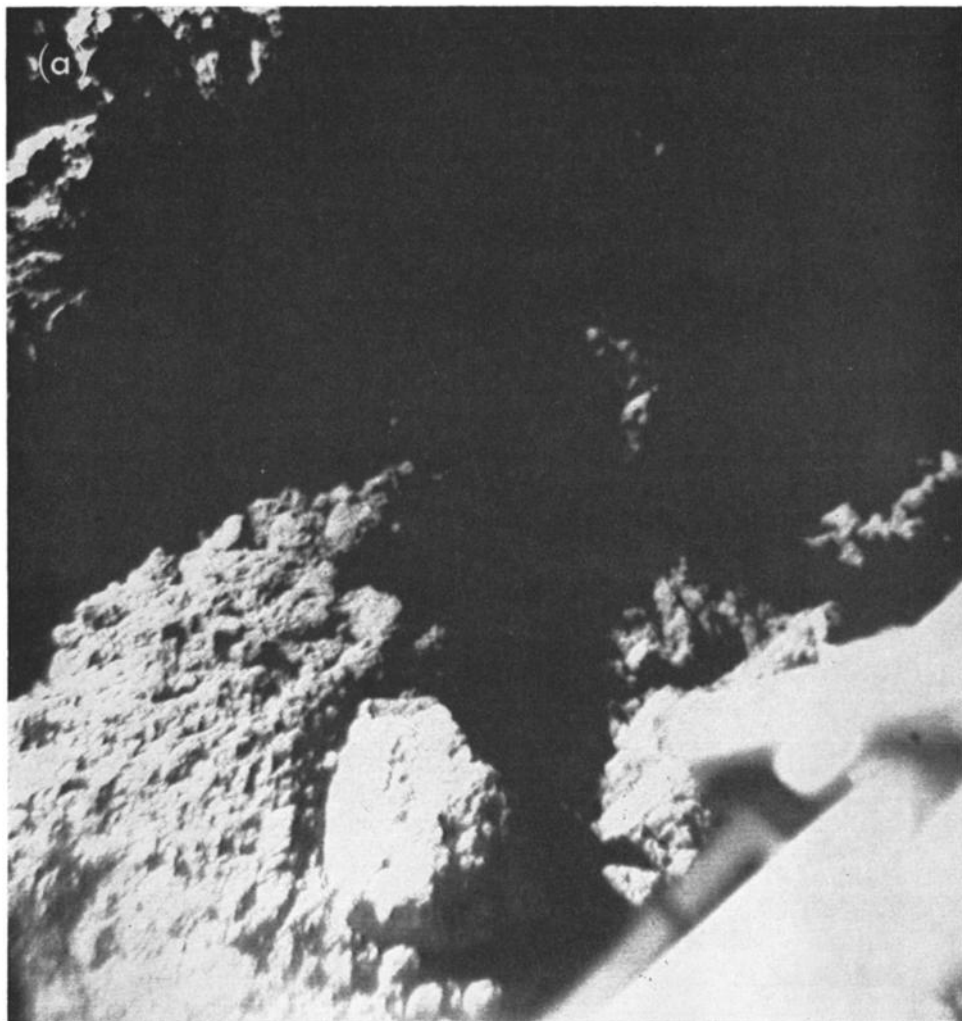
Fig. 28a. Rock E before breaking.

lunar rocks so that a polarizing sequence of pictures could be taken on any fresh surface that might be revealed. For this purpose, another rock (rock E), lying at the foot of trench 1, was selected because of the suitable viewing angle and the nearness of the rock for pictures. Figure 28a is a picture of rock E before it was broken by the surface sampler. After the open scoop was located appropriately on the rock's surface, the surface sampler was elevated to a height of about 35 to 40 cm above the rock and the clutch was operated. After the impact, the rock had moved slightly toward the spacecraft, and a fragment of the rock had been broken

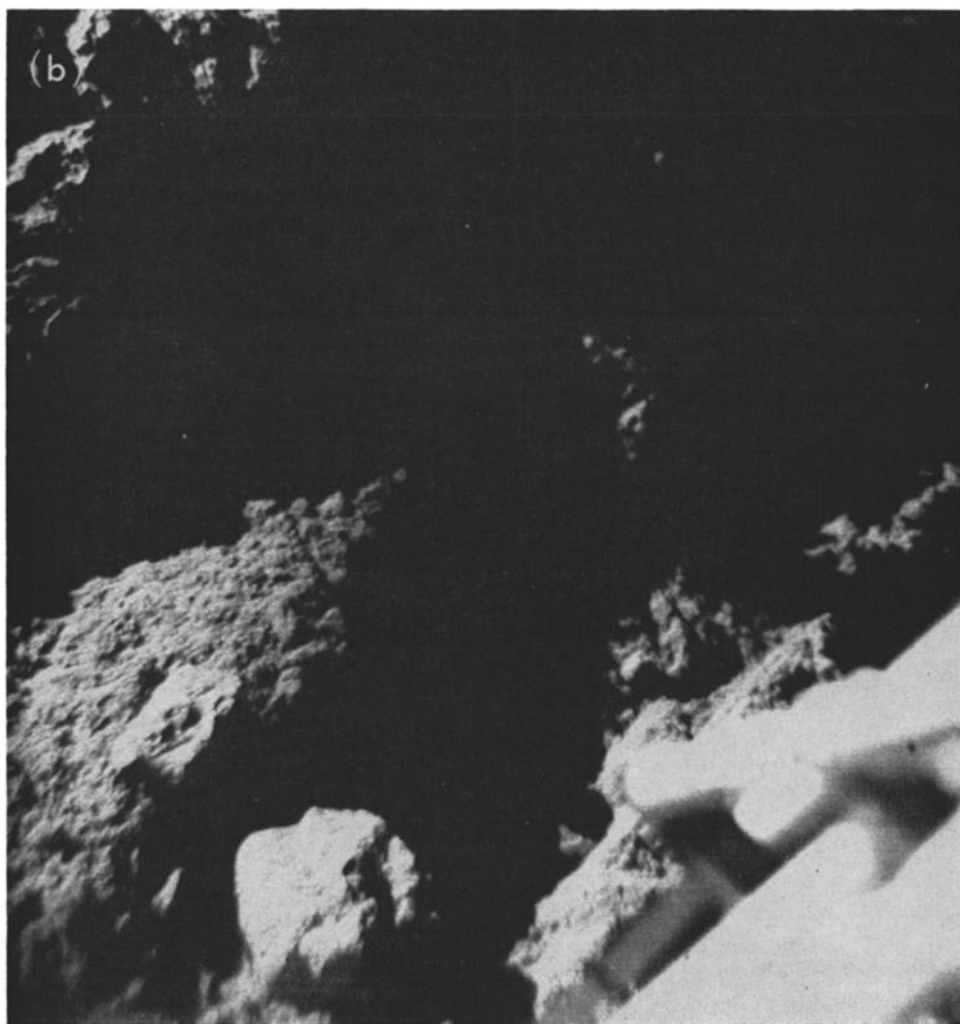
Fig. 28b. Rock E after breaking.

off (Figures 28b and 28c); Figure 28c affords a slightly better view of the broken fragment. After this operation, a polarimetric study of the rock was made.

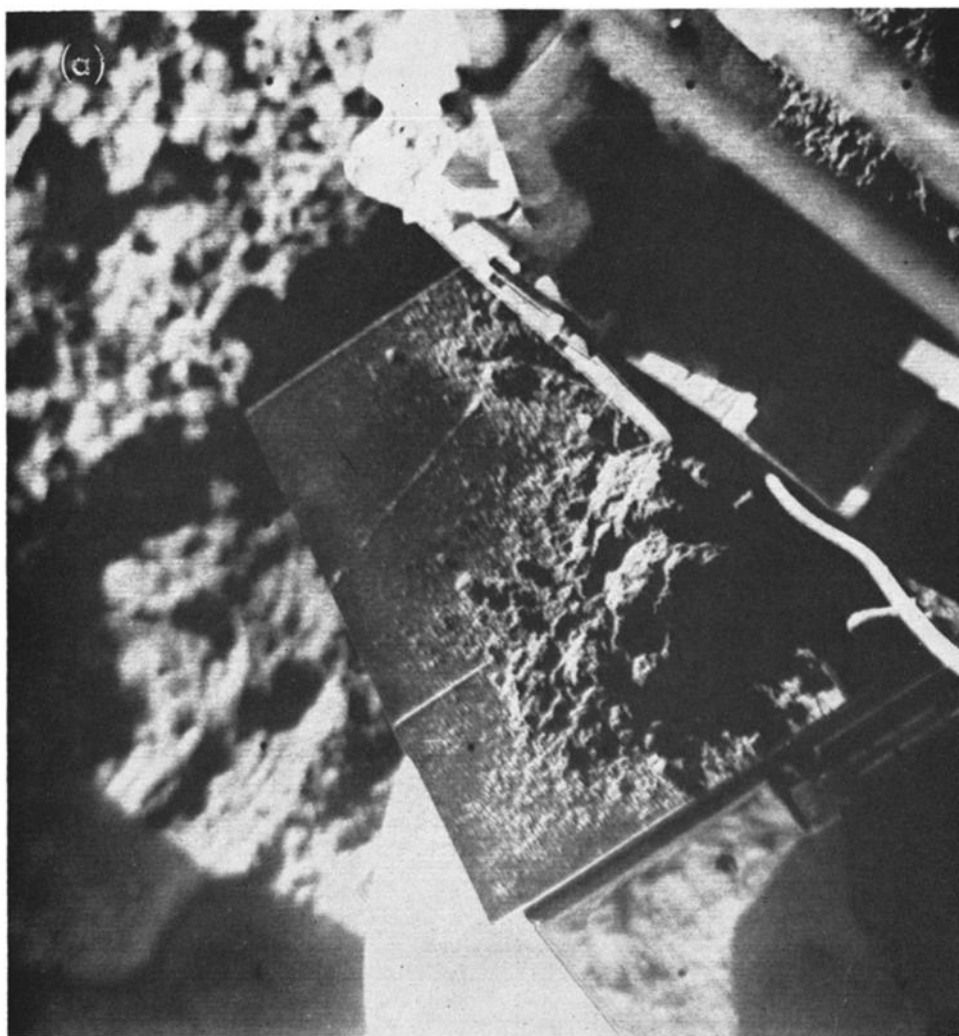
Fig. 29a. Lunar soil dropped on the sensor-head thermal mirror.

Other operations. When the sensor head of the α -scattering instrument was being moved to its second location, a certain amount of soil that had adhered to the surface-sampler scoop was dropped on top of the mirror surface, giving it the appearance shown in Figure 29a. When the sensor head had been in its second sampling position for approximately 24 hours, it was moved by the surface sampler to its third location. The sequence of operations involved first

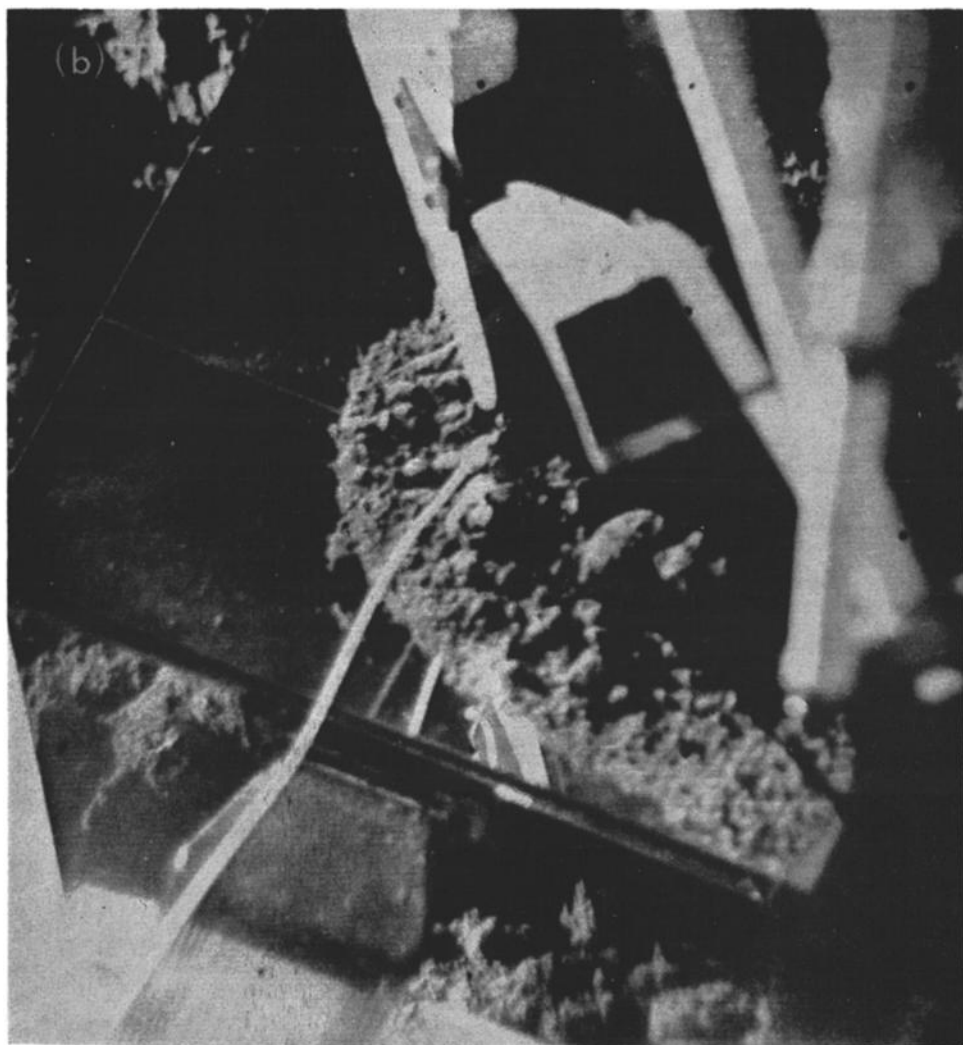
Fig. 29b. After redeployment of sensor head, showing soil movement.

picking up the sensor head and then making a series of movements to the right in 0.1-second steps. This type of motion is quite jerky, and the appearance of the sensor head after two of these right steps is shown in Figure 29b. It can be seen that some of the soil on the α -scattering instrument has slid to one side during the motion, leaving a fairly clean surface with only a fine coating of dust. Since the mirror surface is made of Vycor glass, a comparison of Figures 29a and 29b would seem to indicate that, over a 24-hour period, strong adherence of the lunar surface material to the surface of the mirror did not develop.
